Comer Homes Group

North London Business Park

Phase 2 Geo-environmental and Geotechnical Site
Investigation

1921321-R01(00)

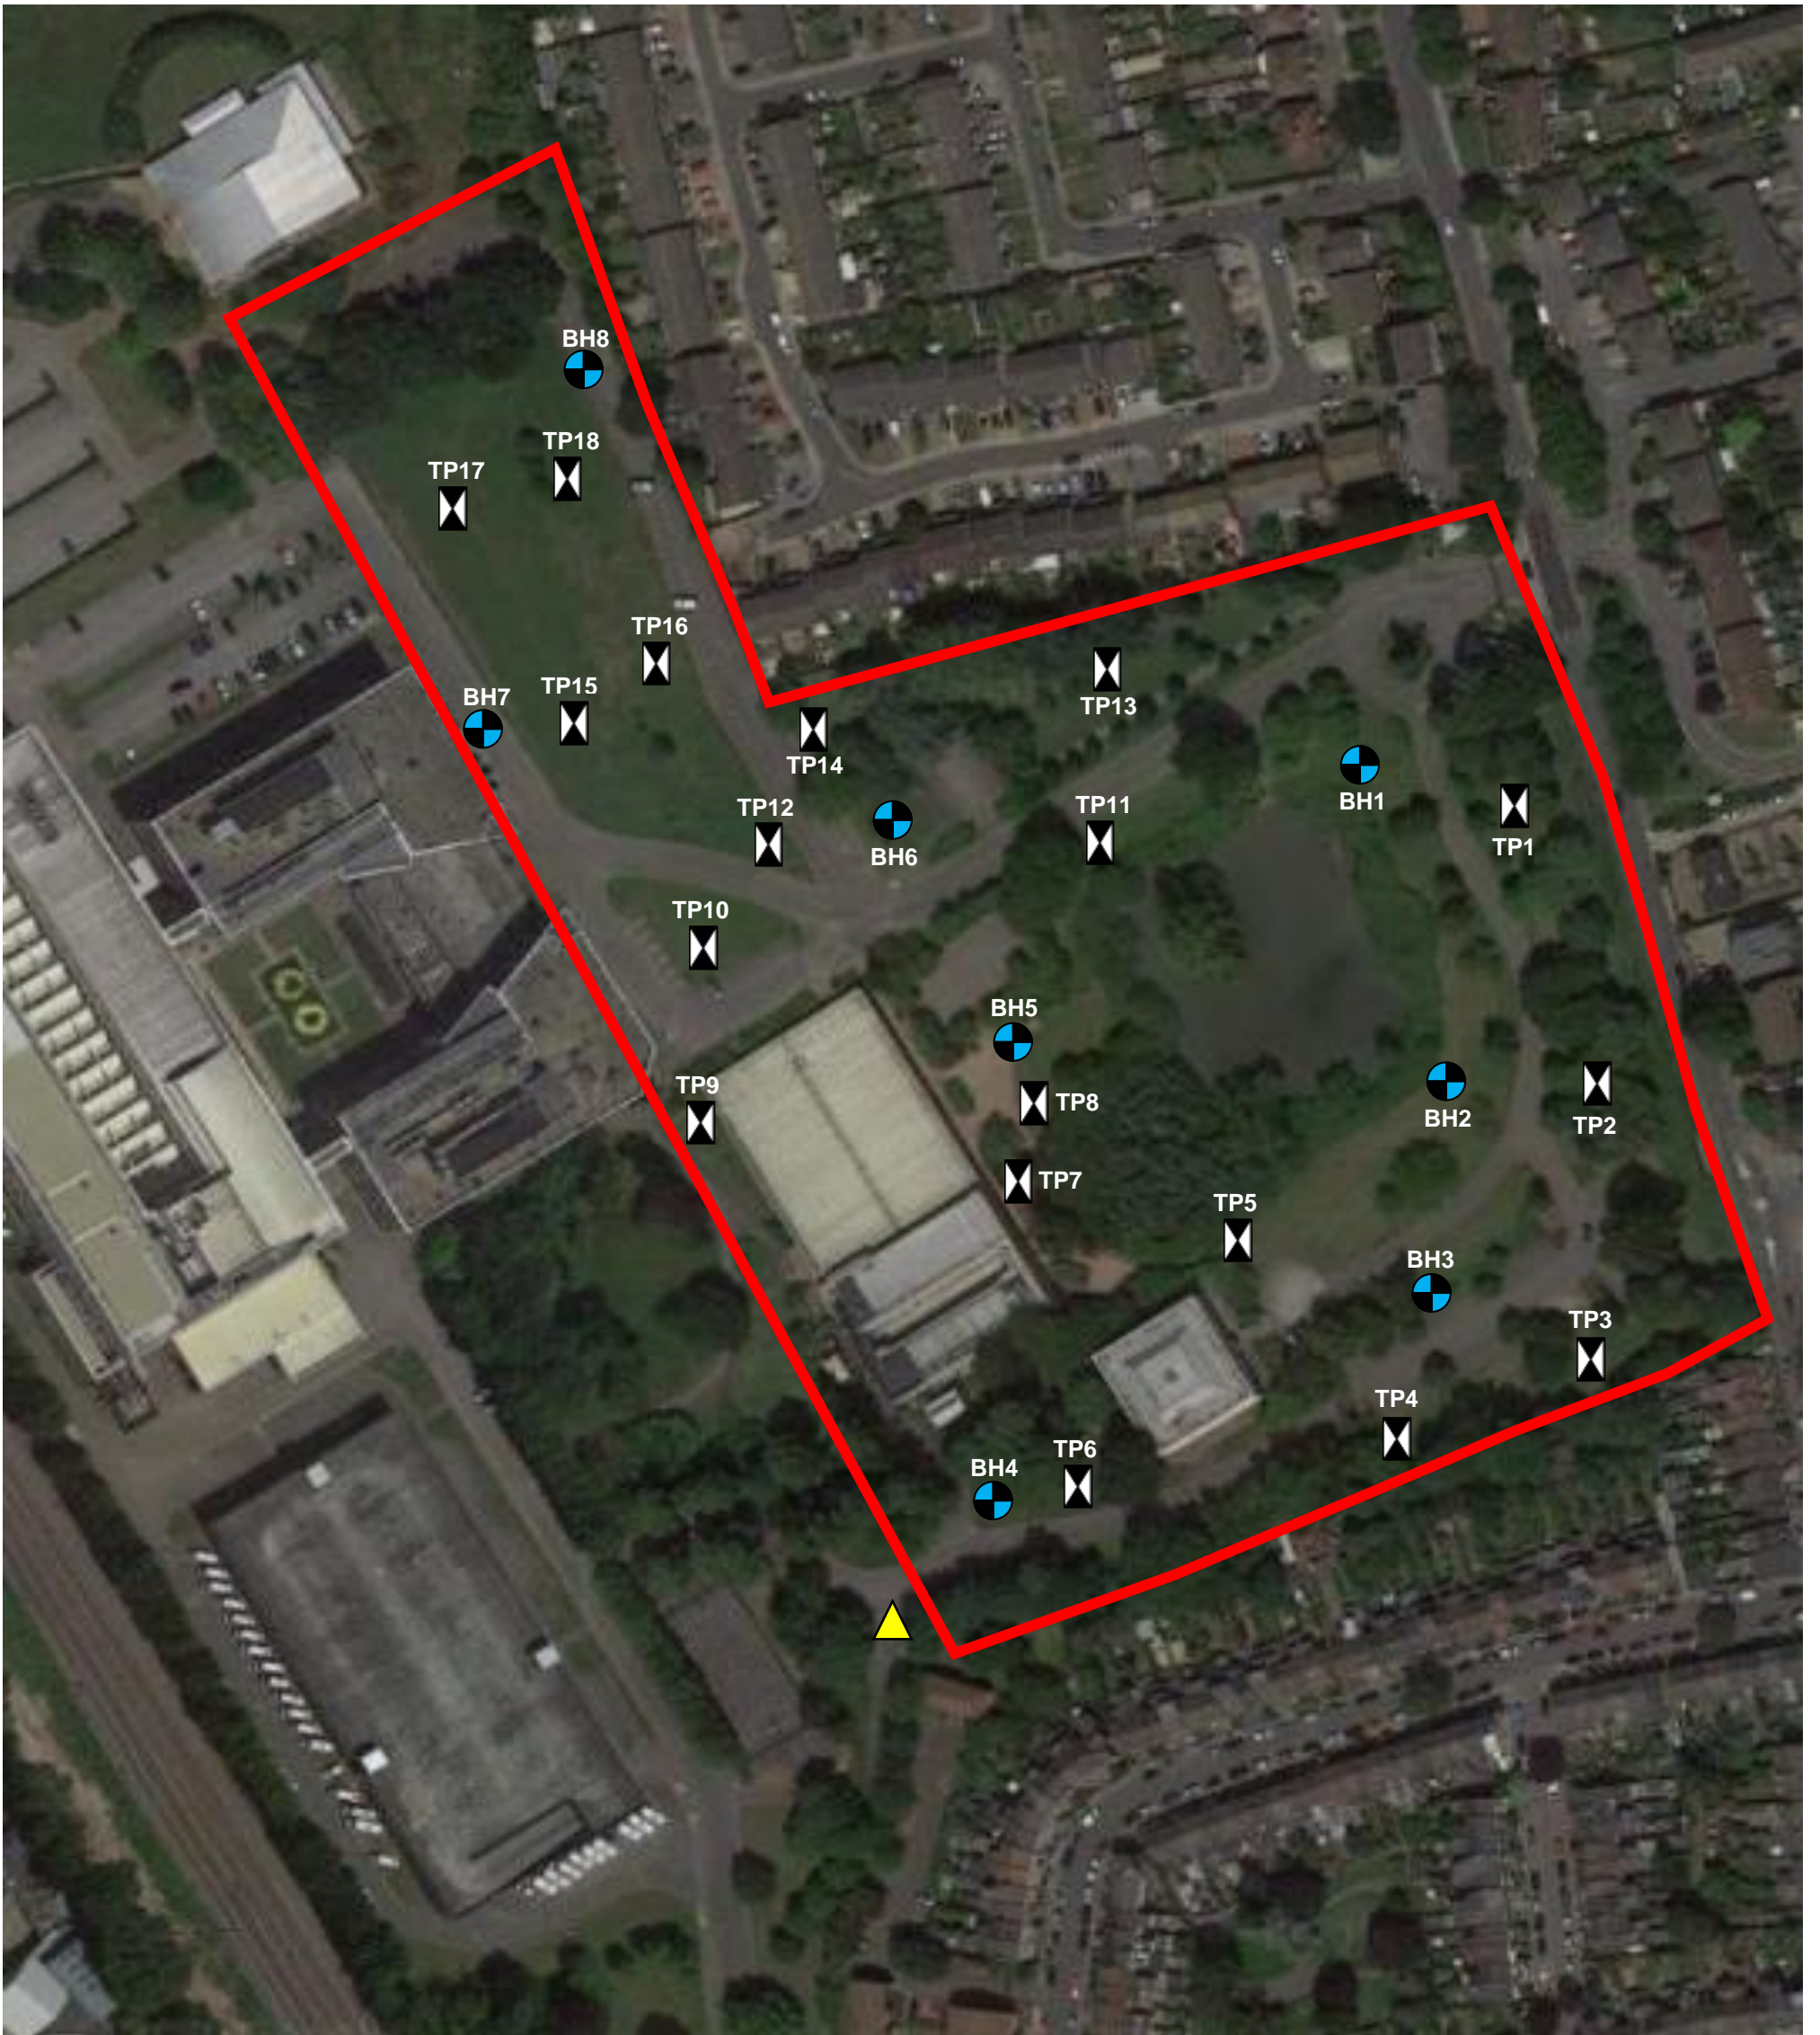
Key:	Cable Percussive Borehole	Mechanically Excavated Trial Pit	Site Store, Skip and Welfare Point
-------------	---------------------------	----------------------------------	------------------------------------

As shown above, consistent elevated concentrations of carbon dioxide were reported at the monitoring locations across the 3 No. return visits. It is noted that with reference to the exploratory hole location plan provided as **Figure 2**, these monitoring locations are spread across the entire site.
